Ensuring Shield Integrity in Field Testing

SMART BUILDINGS TECHNOLOGY

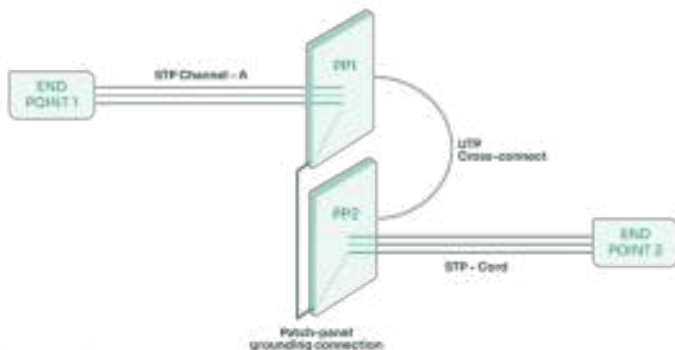
Fig 1 - DC continuity present but shielding compromised

Commonly, shield integrity is verified by simple DC continuity measurements. However, there are situations where shield integrity might be compromised despite having end-to-end DC connection of the shield conductor. Even when the channel has one or more unshielded components, there may be an alternate DC conduction path, for example, through grounding of the patch-panels (Fig. 1). When such alternate conduction path is present for shield, simple continuity measurement may give a false PASS. The good news is, even in such cases, testers like TestPro and NSA can detect shield discontinuities through AC (RF) measurements. Further, these tools pin-point the location where shield discontinuity is detected, which is extremely useful information while troubleshooting the shield issues.

The most common cause of compromised shield integrity is unintended use of unshielded components in a shielded channel. A typical example is use of UTP cord and/or an unshielded connector in otherwise shielded channel. Unshielded components have significantly lower immunity against surrounding electro-magnetic interference (EMI). Unfortunately, noise coupled into this unshielded stretch of the channel, however small it might be, propagates across the channel; eventually appearing at the receiver and causing deterioration in transmission performance.

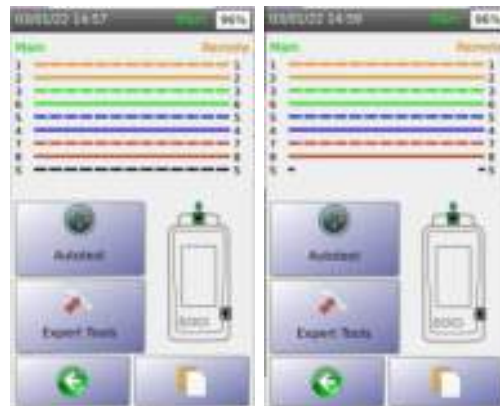
Fig 2 - Cable with good shielding and broken shield (DC shield discontinuity)

First, a regular check on DC continuity is performed using wiremap measurement. Fig. 2 shows two scenarios, one with good shield, and second with open shield. After performing DC continuity check, as an integral part of the RF measurements, the tester performs a special type of measurement called CMRL (common mode return loss) on each pair of the cabling. By analysing the variations on CMRL along the length of the cable, shield defects can be accurately identified (even in the presence of alternative DC conduction path). Let's look at how this is done.

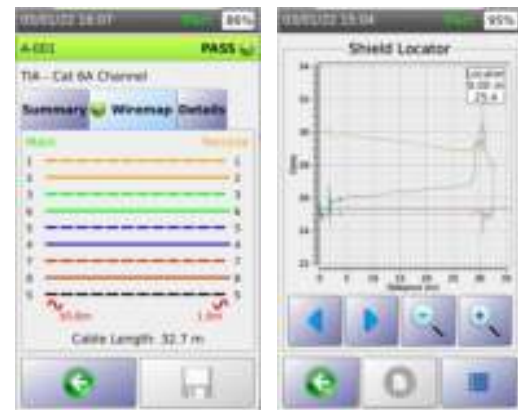
Fig 3 - Cable with AC shielding discontinuity and its time domain locator plot

As seen from Fig. 3, a cable having AC shield discontinuity is detected by the tester accurately. The tester also provides a locator (time-domain) plot of the measurement for in-depth analysis of the cable behaviour.

common mode signal can be viewed as injecting noise on purpose. The instrument then analyses reflected signal by adding the voltages on the two wires instead of usual subtraction (as noise is what we are interested in for the purpose of this measurement). It then finds magnitude and delay of this reflected common mode signal. A strong reflection means discontinuity in the shield. The delay associated with this strong reflection represents the location of the discontinuity.

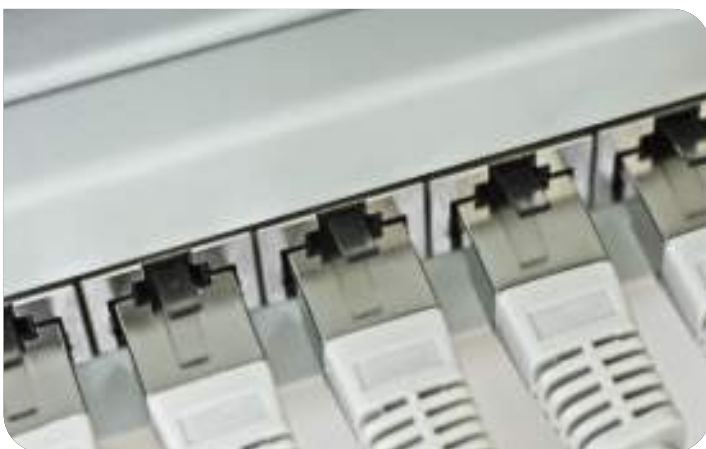
In the measurement method described above, the AEM testers perform further post processing of data to find actual impedance changes along the length of the cable on common mode signals. In addition to improving measurement reliability, this also gives unique ability to identify transition of cabling construction technologies, such as from SSTP to FTP.
